Asbestos Management Survey Report

(Carried out for Charminster Close
Residents Company Ltd)

Charminster Close, Blocks A-E, Nythe, Swindon,
SN3 3QB

Checked by:	J O'Sullivan
Verified/Signature:	
Date of Survey:	5 April 2011
Date of Report:	14 th April 2011
<u>Our Reference:</u>	<u>SAS5350</u>
Authorising Surveyor:	Kerry Salter
Verified/Signature:

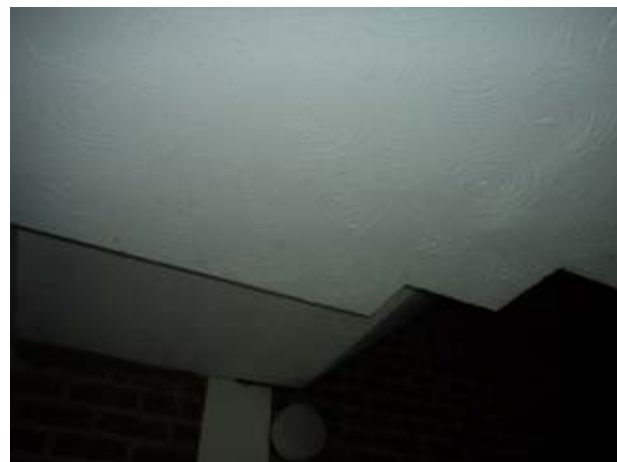
Our Sample Ref	Laboratory Sample Ref	Floor	Location	Description	Qty	Analysis Result	Total M.A.S	Notifiable Material Y/N
5350/1	107375	Ground Floor	Entrance Lobby	Ceiling Decorative Coating	11m ²	Chrysotile	2	N

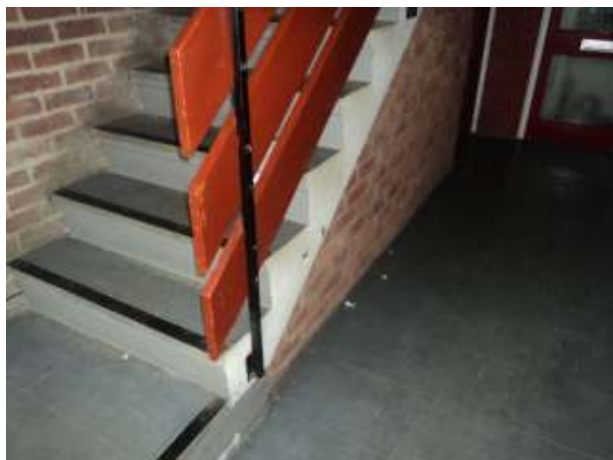
Our Sample Ref	Laboratory Sample Ref	Floor	Location	Description	Qty	Analysis Result	Total M.A.S	Notifiable Material Y/N
5350/2	107376	Ground Floor	Entrance Lobby	Floor & Stairs Tile & Adhesive	10m ²	No asbestos detected in sample	N/A	N/A

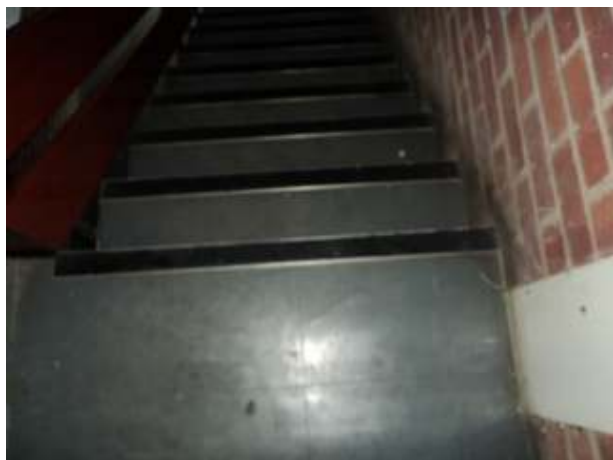
Our Sample Ref	Laboratory Sample Ref	Floor	Location	Description	Qty	Analysis Result	Total M.A.S	Notifiable Material Y/N
5350/3	107377	Ground Floor	Entrance Lobby	Stair Nosings	13 no	No asbestos detected in sample	N/A	N/A

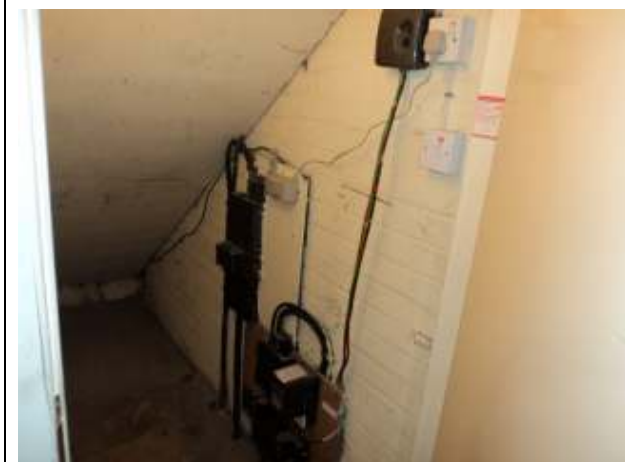
Our Sample Ref	Laboratory Sample Ref	Floor	Location	Description	Qty	Analysis Result	Total M.A.S	Notifiable Material Y/N
Presumed	Presumed	Ground Floor	Cleaners Store	Wall Switch Gear Textile	3 units	Presumed Chrysotile	4	N

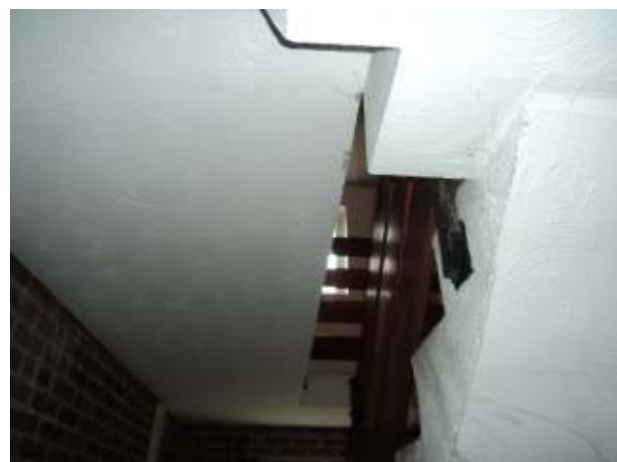
Our Sample Ref	Laboratory Sample Ref	Floor	Location	Description	Qty	Analysis Result	Total M.A.S	Notifiable Material Y/N
Refer 5350/1	Refer 107375	1 st Floor	Landing	Ceiling Decorative Coating	8m ²	Chrysotile	2	N

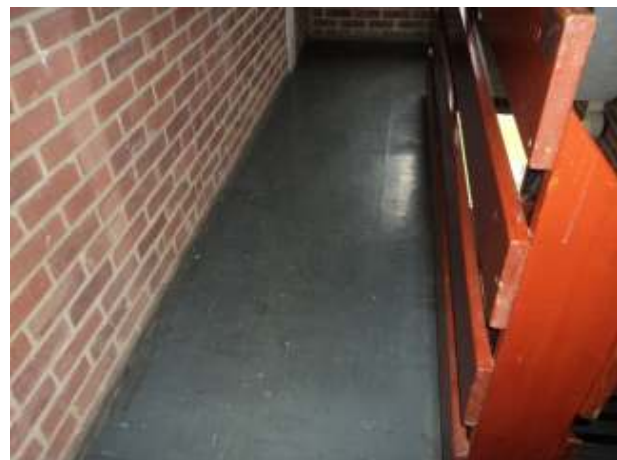
Our Sample Ref	Laboratory Sample Ref	Floor	Location	Description	Qty	Analysis Result	Total M.A.S	Notifiable Material Y/N
Refer 5350/2	Refer 107376	1 st Floor	Landing	Floor & Stairs Tile & Adhesive	12m ²	No asbestos detected in sample	N/A	N/A

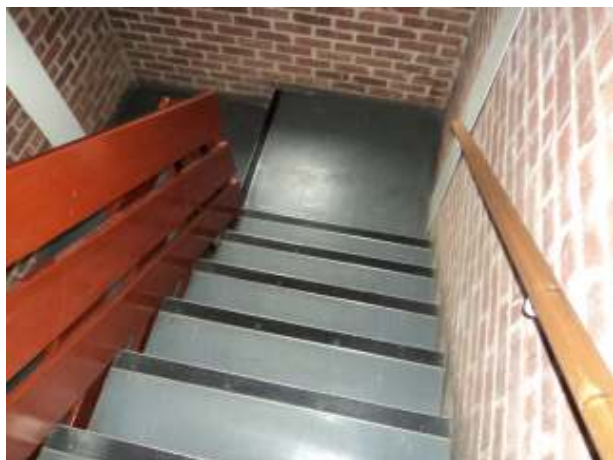
Our Sample Ref	Laboratory Sample Ref	Floor	Location	Description	Qty	Analysis Result	Total M.A.S	Notifiable Material Y/N
Refer 5350/3	Refer 107377	1 st Floor	Landing	Stair Nosings	13 no	No asbestos detected in sample	N/A	N/A

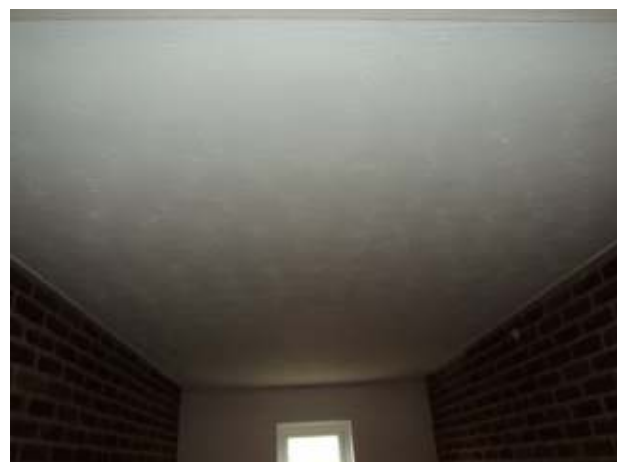
Our Sample Ref	Laboratory Sample Ref	Floor	Location	Description	Qty	Analysis Result	Total M.A.S	Notifiable Material Y/N
Refer 5350/1	Refer 107375	2 nd Floor	Landing	Ceiling Decorative Coating	9m ²	Chrysotile	2	N

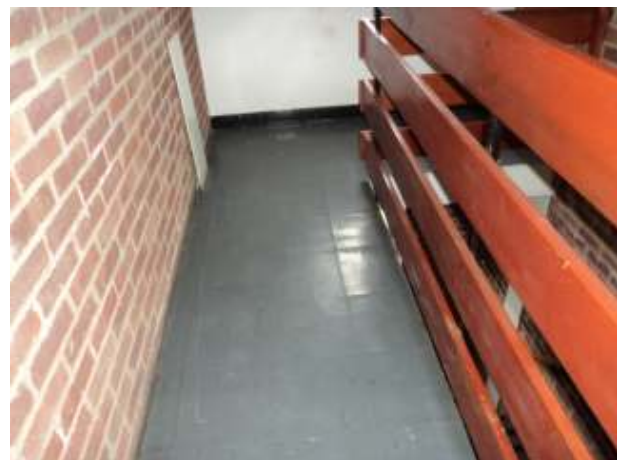
Our Sample Ref	Laboratory Sample Ref	Floor	Location	Description	Qty	Analysis Result	Total M.A.S	Notifiable Material Y/N
Refer 5350/2	Refer 107376	2 nd Floor	Landing	Floor Tile & Adhesive	6m ²	No asbestos detected in sample	N/A	N/A

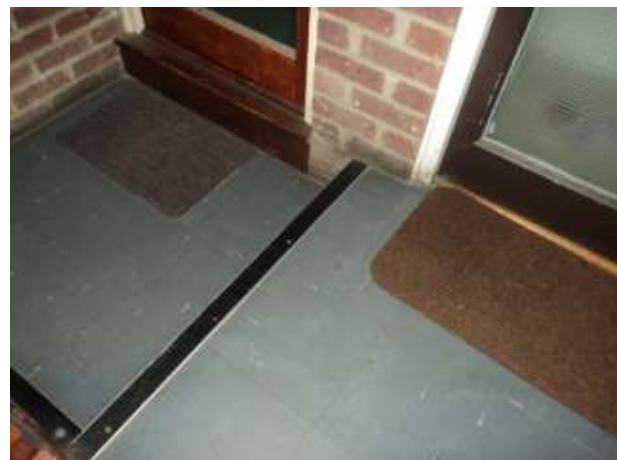
Our Sample Ref	Laboratory Sample Ref	Floor	Location	Description	Qty	Analysis Result	Total M.A.S	Notifiable Material Y/N
Refer 5350/3	Refer 107377	2 nd Floor	Landing	Step Nosing	1 no	No asbestos detected in sample	N/A	N/A

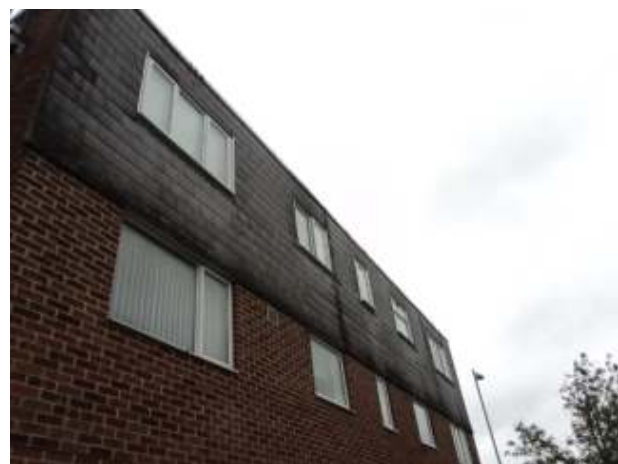
Our Sample Ref	Laboratory Sample Ref	Floor	Location	Description	Qty	Analysis Result	Total M.A.S	Notifiable Material Y/N
5350/4	107378	2 nd Floor	External Front & Rear Elevation	Asbestos Cement Shingles	80m ²	Chrysotile	3	N

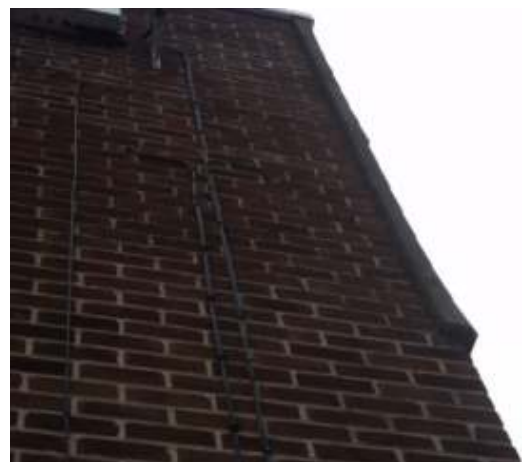
Our Sample Ref	Laboratory Sample Ref	Floor	Location	Description	Qty	Analysis Result	Total M.A.S	Notifiable Material Y/N
Refer 5350/4	Refer 107378	2 nd Floor	External Front & Rear Elevation	Asbestos Cement Under-Cloak	16m	Chrysotile	3	N

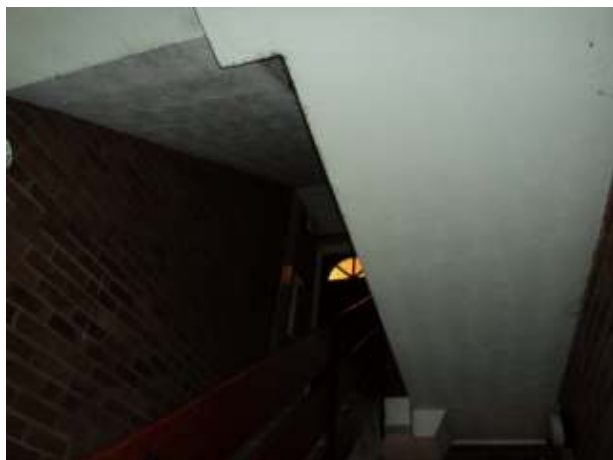
Our Sample Ref	Laboratory Sample Ref	Floor	Location	Description	Qty	Analysis Result	Total M.A.S	Notifiable Material Y/N
5350/5	107379	Ground Floor	Entrance Lobby	Ceiling Decorative Coating	11m ²	Chrysotile	2	N

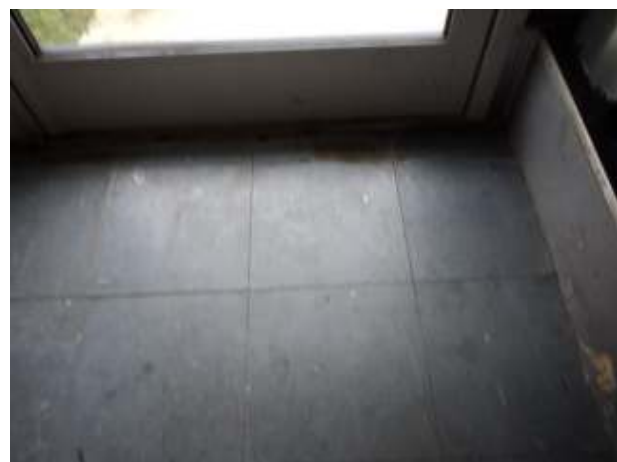
Our Sample Ref	Laboratory Sample Ref	Floor	Location	Description	Qty	Analysis Result	Total M.A.S	Notifiable Material Y/N
5350/6	107380	Ground Floor	Entrance Lobby	Floor & Stairs Tile & Adhesive	10m ²	No asbestos detected in sample	N/A	N/A

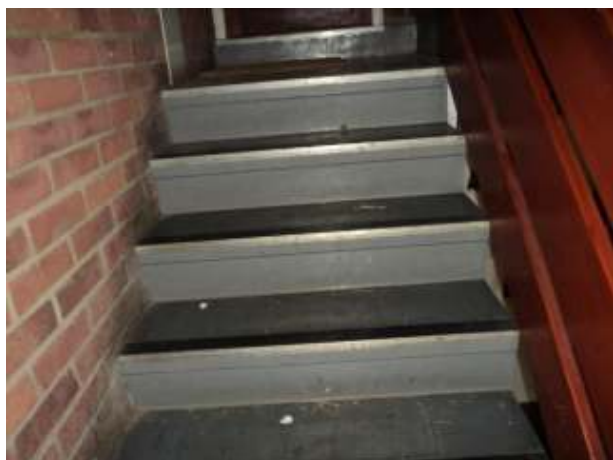
Our Sample Ref	Laboratory Sample Ref	Floor	Location	Description	Qty	Analysis Result	Total M.A.S	Notifiable Material Y/N
5350/7	107381	Ground Floor	Entrance Lobby	Stair Nosings	13 no	No asbestos detected in sample	N/A	N/A

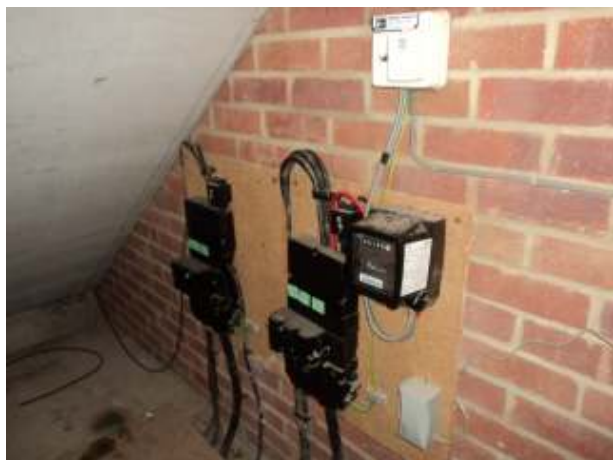
Our Sample Ref	Laboratory Sample Ref	Floor	Location	Description	Qty	Analysis Result	Total M.A.S	Notifiable Material Y/N
Presumed	Presumed	Ground Floor	Cleaners Store Wall	Switch Gear Textile	3 units	Chrysotile	4	N

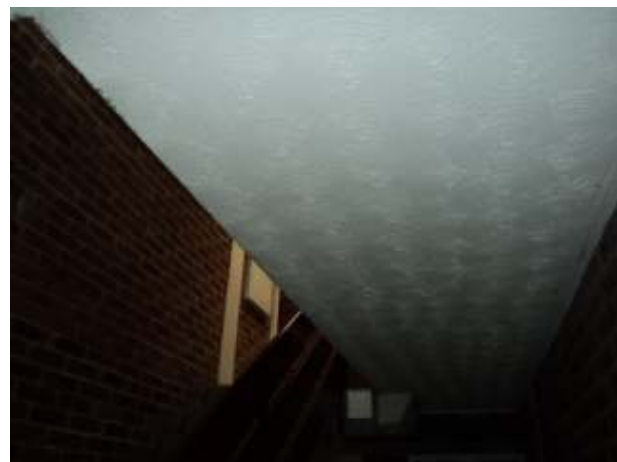
Our Sample Ref	Laboratory Sample Ref	Floor	Location	Description	Qty	Analysis Result	Total M.A.S	Notifiable Material Y/N
Refer 5350/5	Refer 107379	1 st Floor	Landing	Ceiling Decorative Coating	8m ²	Chrysotile	2	N

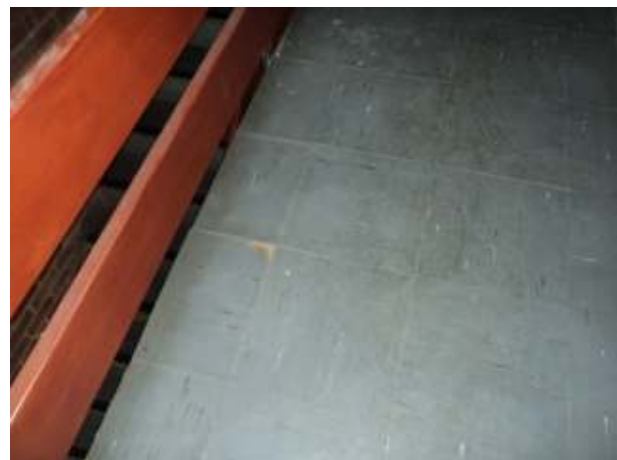
Our Sample Ref	Laboratory Sample Ref	Floor	Location	Description	Qty	Analysis Result	Total M.A.S	Notifiable Material Y/N
Refer 5350/6	Refer 107380	1 st Floor	Landing	Floor & Stairs Tile & Adhesive	12m ²	No asbestos detected in sample	N/A	N/A

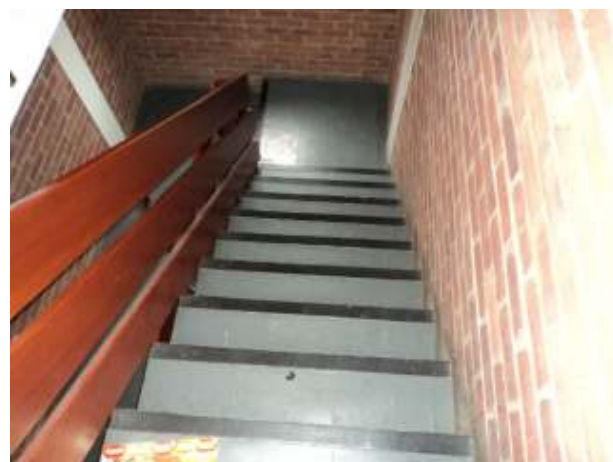
Our Sample Ref	Laboratory Sample Ref	Floor	Location	Description	Qty	Analysis Result	Total M.A.S	Notifiable Material Y/N
Refer 5350/7	Refer 107381	1 st Floor	Landing	Stair Nosings	13 no	No asbestos detected in sample	N/A	N/A

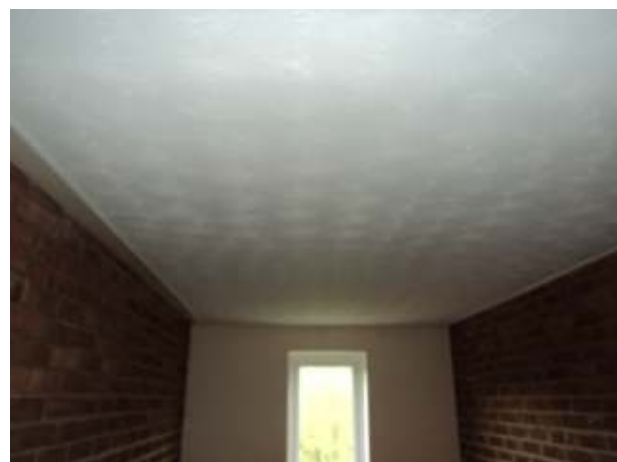
Our Sample Ref	Laboratory Sample Ref	Floor	Location	Description	Qty	Analysis Result	Total M.A.S	Notifiable Material Y/N
Refer 5350/5	Refer 107379	2 nd Floor	Landing	Ceiling Decorative Coating	9m ²	Chrysotile	2	N

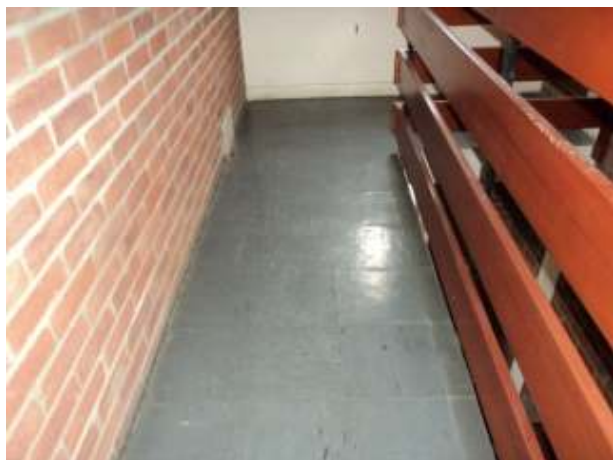
Our Sample Ref	Laboratory Sample Ref	Floor	Location	Description	Qty	Analysis Result	Total M.A.S	Notifiable Material Y/N
Refer 5350/6	Refer 107380	2 nd Floor	Landing	Floor Tile & Adhesive	6m ²	No asbestos detected in sample	N/A	N/A

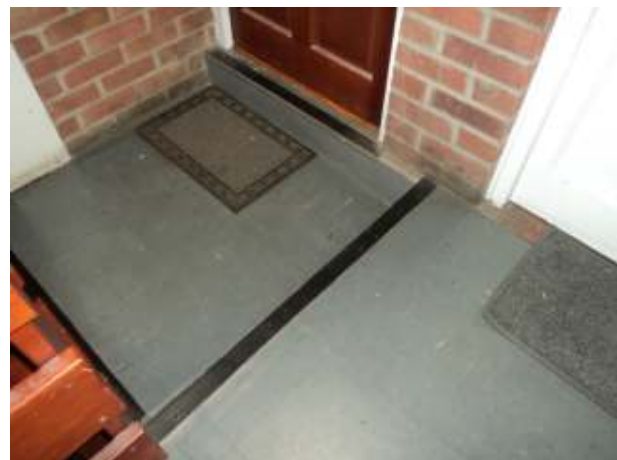
Our Sample Ref	Laboratory Sample Ref	Floor	Location	Description	Qty	Analysis Result	Total M.A.S	Notifiable Material Y/N
Refer 5350/7	Refer 107381	2 nd Floor	Landing	Step Nosings	1 no	No asbestos detected in sample	N/A	N/A

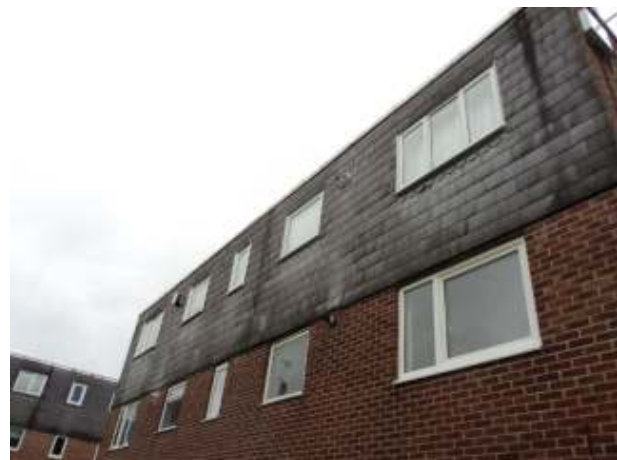
Our Sample Ref	Laboratory Sample Ref	Floor	Location	Description	Qty	Analysis Result	Total M.A.S	Notifiable Material Y/N
5350/8	107382	2 nd Floor	External Front & Rear Elevation	Asbestos Cement Shingles	80m ²	Chrysotile	3	N

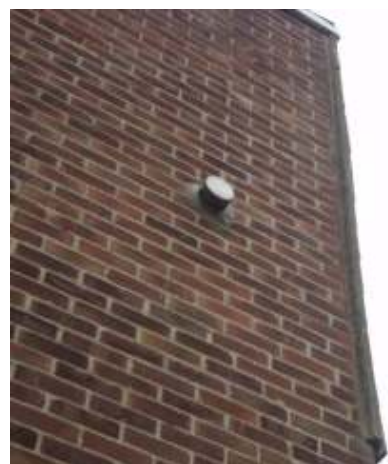
Our Sample Ref	Laboratory Sample Ref	Floor	Location	Description	Qty	Analysis Result	Total M.A.S	Notifiable Material Y/N
Refer 5350/8	Refer 107382	2 nd Floor	External Front & Rear Elevation	Asbestos Cement Under-Cloak	16m	Chrysotile	3	N

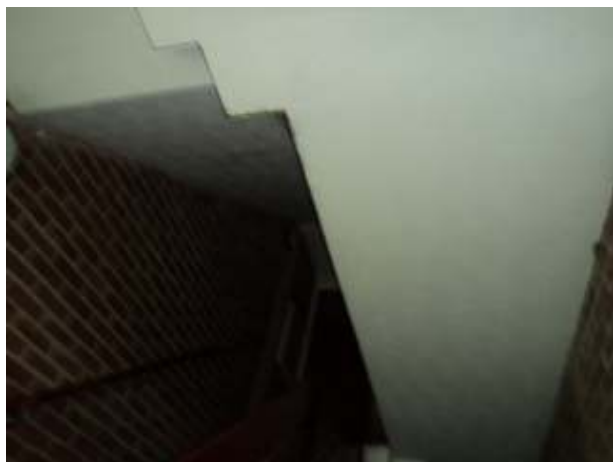
Our Sample Ref	Laboratory Sample Ref	Floor	Location	Description	Qty	Analysis Result	Total M.A.S	Notifiable Material Y/N
5350/9	107383	Ground Floor	Entrance Lobby	Ceiling Decorative Coating	11m ²	Chrysotile	2	N

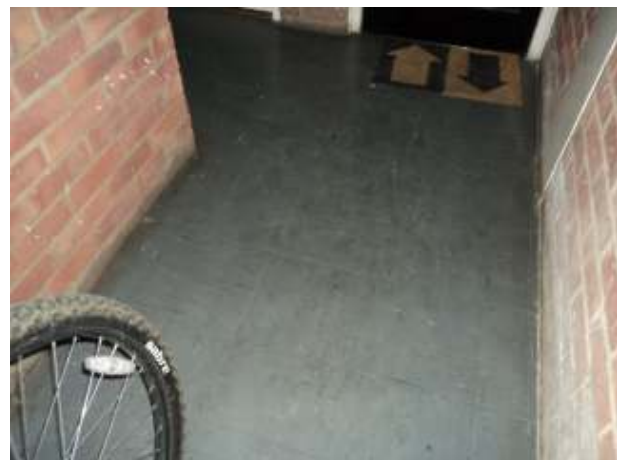
Our Sample Ref	Laboratory Sample Ref	Floor	Location	Description	Qty	Analysis Result	Total M.A.S	Notifiable Material Y/N
5350/10	107384	Ground Floor	Entrance Lobby	Floor & Stairs Tile & Adhesive	10m ²	No asbestos detected in sample	N/A	N/A

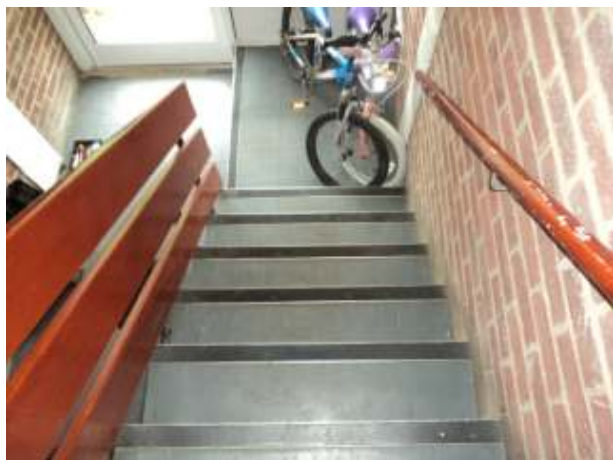
Our Sample Ref	Laboratory Sample Ref	Floor	Location	Description	Qty	Analysis Result	Total M.A.S	Notifiable Material Y/N
5350/11	107385	Ground Floor	Entrance Lobby	Stair Nosings	13 no	No asbestos detected in sample	N/A	N/A

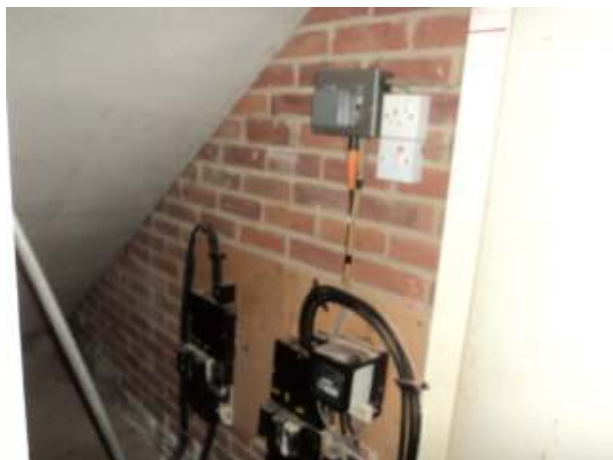
Our Sample Ref	Laboratory Sample Ref	Floor	Location	Description	Qty	Analysis Result	Total M.A.S	Notifiable Material Y/N
Presumed	Presumed	Ground Floor	Cleaners Store Wall	Switch Gear Textile	3 units	Chrysotile	4	N

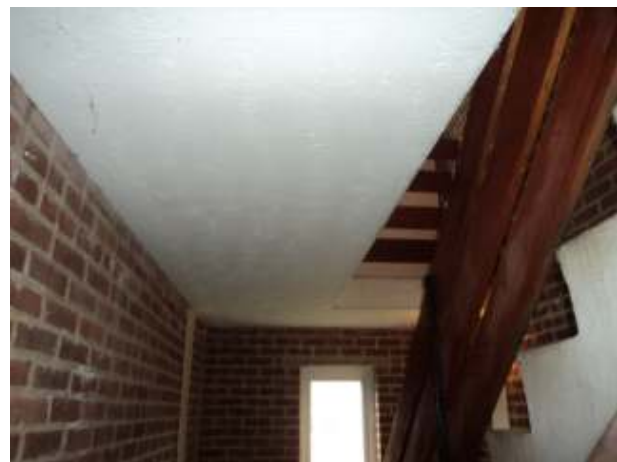
Our Sample Ref	Laboratory Sample Ref	Floor	Location	Description	Qty	Analysis Result	Total M.A.S	Notifiable Material Y/N
Refer 5350/9	Refer 107383	1 st Floor	Landing	Ceiling Decorative Coating	8m ²	Chrysotile	2	N

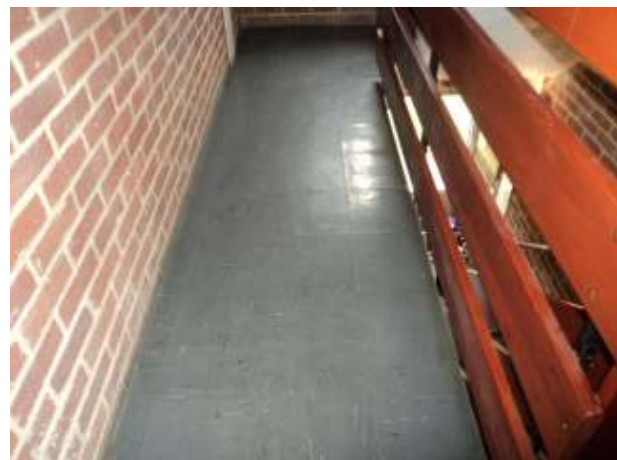
Our Sample Ref	Laboratory Sample Ref	Floor	Location	Description	Qty	Analysis Result	Total M.A.S	Notifiable Material Y/N
Refer 5350/10	Refer 107384	1 st Floor	Landing	Floor & Stairs Tile & Adhesive	12m ²	No asbestos detected in sample	N/A	N/A

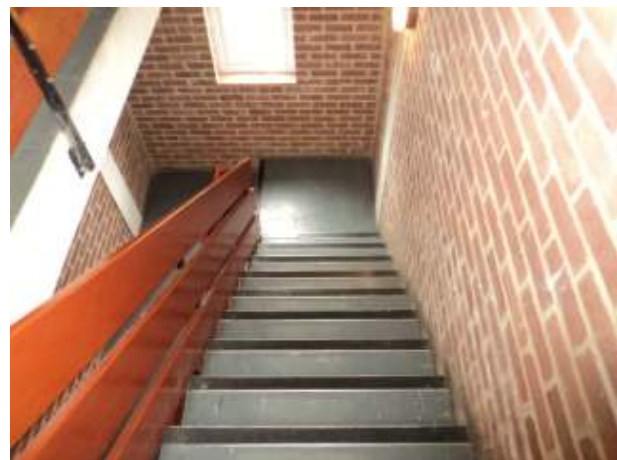
Our Sample Ref	Laboratory Sample Ref	Floor	Location	Description	Qty	Analysis Result	Total M.A.S	Notifiable Material Y/N
Refer 5350/11	Refer 107385	1 st Floor	Landing	Stair Nosings	13 no	No asbestos detected in sample	N/A	N/A

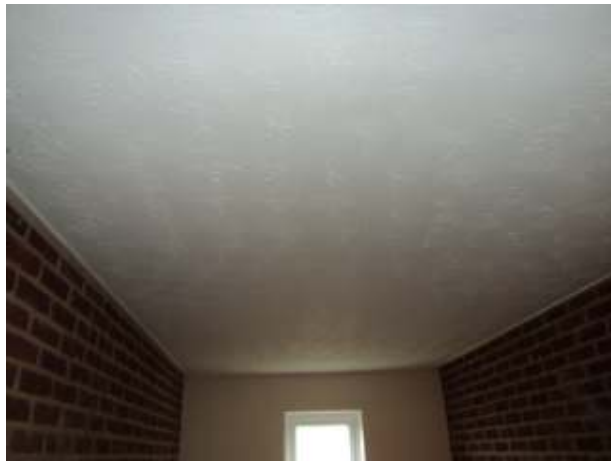
Our Sample Ref	Laboratory Sample Ref	Floor	Location	Description	Qty	Analysis Result	Total M.A.S	Notifiable Material Y/N
Refer 5350/9	Refer 107383	2 nd Floor	Landing	Ceiling Decorative Coating	9m ²	Chrysotile	2	N

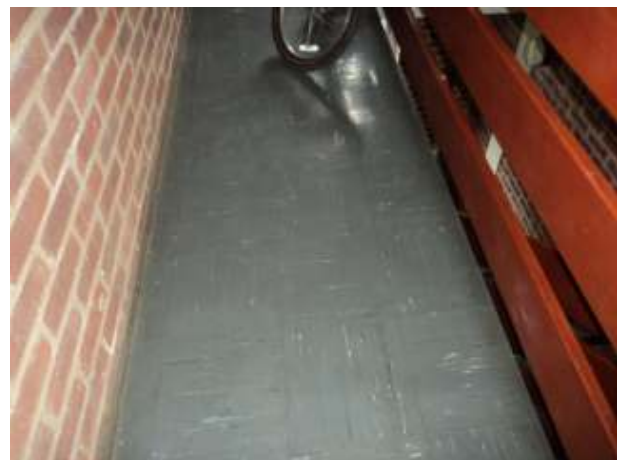
Our Sample Ref	Laboratory Sample Ref	Floor	Location	Description	Qty	Analysis Result	Total M.A.S	Notifiable Material Y/N
Refer 5350/10	Refer 107384	2 nd Floor	Landing	Floor Tile & Adhesive	6m ²	No asbestos detected in sample	N/A	N/A

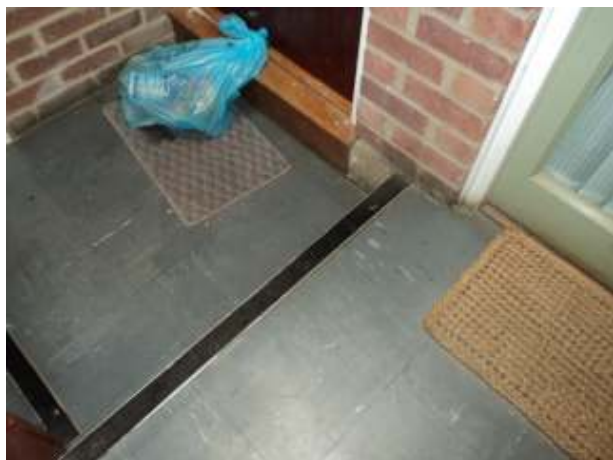
Our Sample Ref	Laboratory Sample Ref	Floor	Location	Description	Qty	Analysis Result	Total M.A.S	Notifiable Material Y/N
Refer 5350/11	Refer 107385	2 nd Floor	Landing	Step Nosing	1 no	No asbestos detected in sample	N/A	N/A

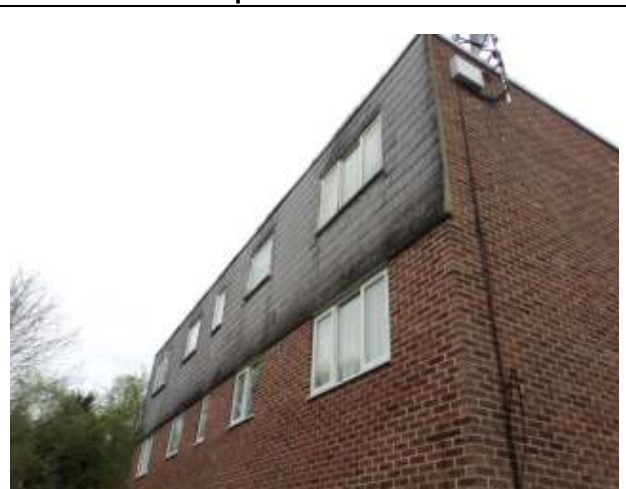
Our Sample Ref	Laboratory Sample Ref	Floor	Location	Description	Qty	Analysis Result	Total M.A.S	Notifiable Material Y/N
5350/12	107386	2 nd Floor	External Front & Rear Elevation	Asbestos Cement Shingles	80m ²	Chrysotile	3	N

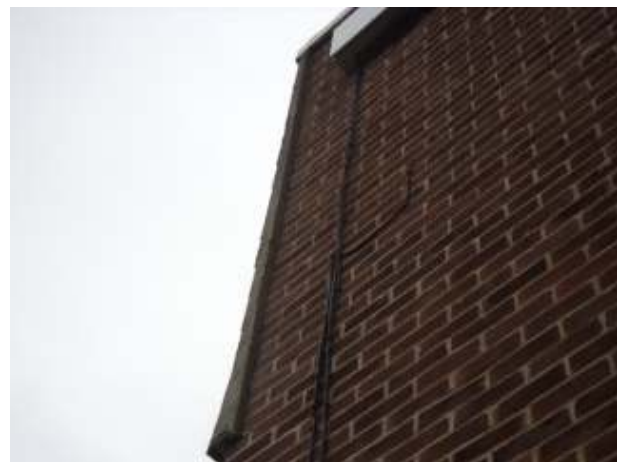
Our Sample Ref	Laboratory Sample Ref	Floor	Location	Description	Qty	Analysis Result	Total M.A.S	Notifiable Material Y/N
Refer 5350/12	Refer 107386	2 nd Floor	External Front & Rear Elevation	Asbestos Cement Under-Cloak	16m	Chrysotile	3	N

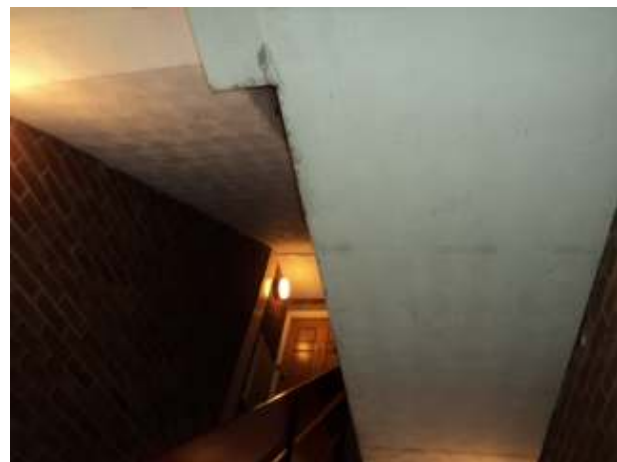
Our Sample Ref	Laboratory Sample Ref	Floor	Location	Description	Qty	Analysis Result	Total M.A.S	Notifiable Material Y/N
5350/13	107387	Ground Floor	Entrance Lobby	Ceiling Decorative Coating	11m ²	Chrysotile	2	N

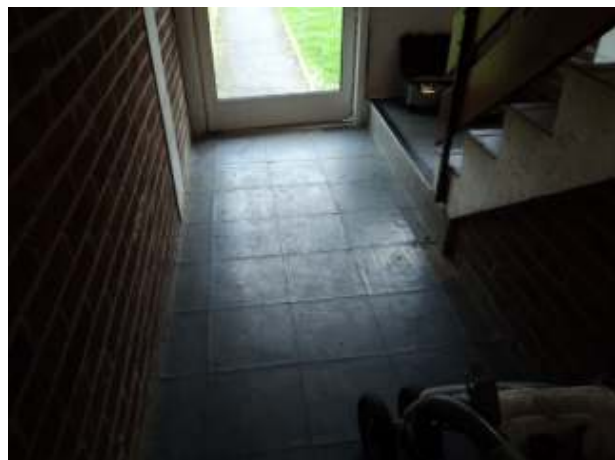
Our Sample Ref	Laboratory Sample Ref	Floor	Location	Description	Qty	Analysis Result	Total M.A.S	Notifiable Material Y/N
5350/14	107388	Ground Floor	Entrance Lobby	Floor & Stairs Tile & Adhesive	10m ²	No asbestos detected in sample	N/A	N/A

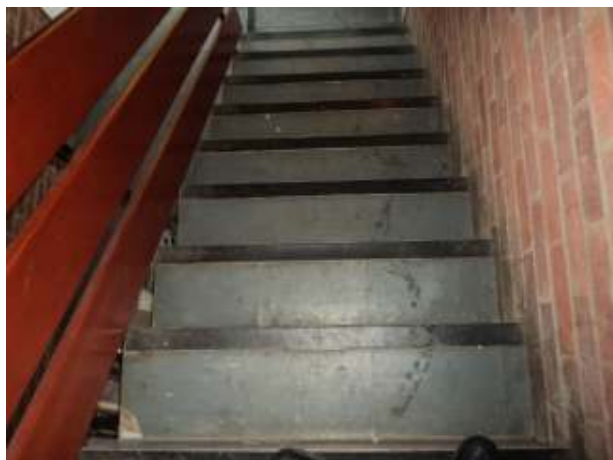
Our Sample Ref	Laboratory Sample Ref	Floor	Location	Description	Qty	Analysis Result	Total M.A.S	Notifiable Material Y/N
5350/15	107389	Ground Floor	Entrance Lobby	Stair Nosings	13 no	No asbestos detected in sample	N/A	N/A

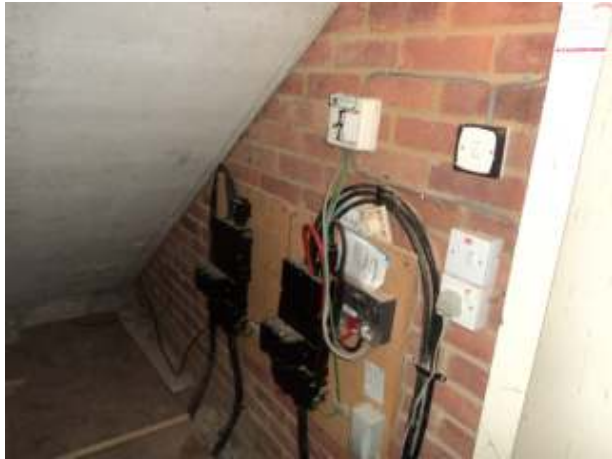
Our Sample Ref	Laboratory Sample Ref	Floor	Location	Description	Qty	Analysis Result	Total M.A.S	Notifiable Material Y/N
Presumed	Presumed	Ground Floor	Cleaners Store Wall	Switch Gear Textile	3 units	Chrysotile	4	N

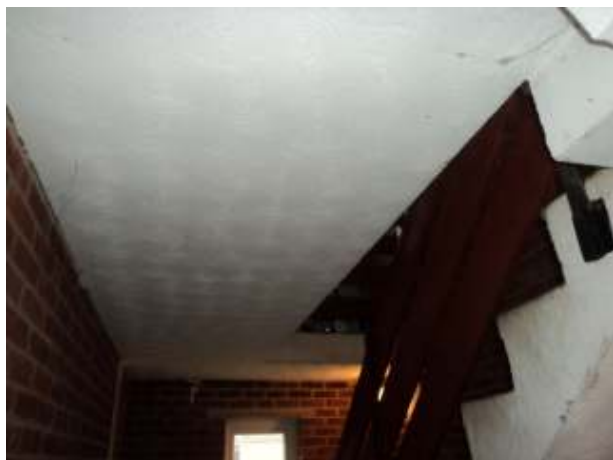
Our Sample Ref	Laboratory Sample Ref	Floor	Location	Description	Qty	Analysis Result	Total M.A.S	Notifiable Material Y/N
Refer 5350/13	Refer 107387	1 st Floor	Landing	Ceiling Decorative Coating	8m ²	Chrysotile	2	N

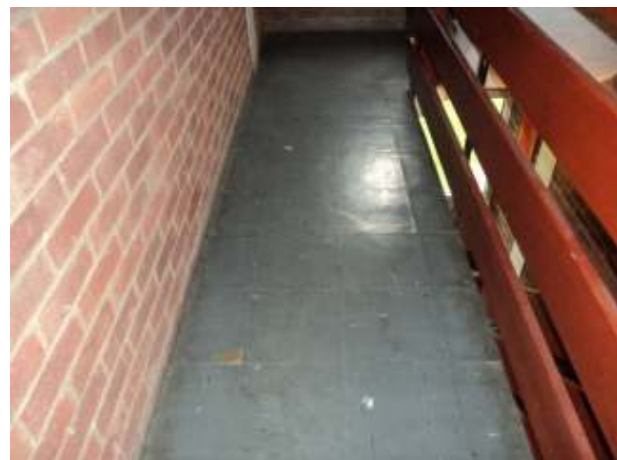
Our Sample Ref	Laboratory Sample Ref	Floor	Location	Description	Qty	Analysis Result	Total M.A.S	Notifiable Material Y/N
Refer 5350/14	Refer 107388	1 st Floor	Landing	Floor & Stairs Tile & Adhesive	12m ²	No asbestos detected in sample	N/A	N/A

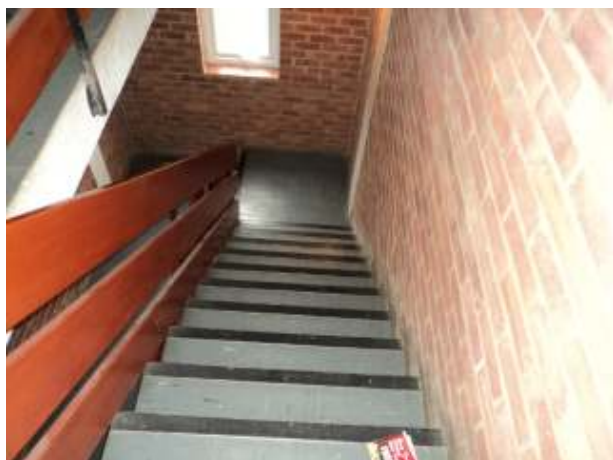
Our Sample Ref	Laboratory Sample Ref	Floor	Location	Description	Qty	Analysis Result	Total M.A.S	Notifiable Material Y/N
Refer 5350/15	Refer 107389	1 st Floor	Landing	Stair Nosings	13 no	No asbestos detected in sample	N/A	N/A

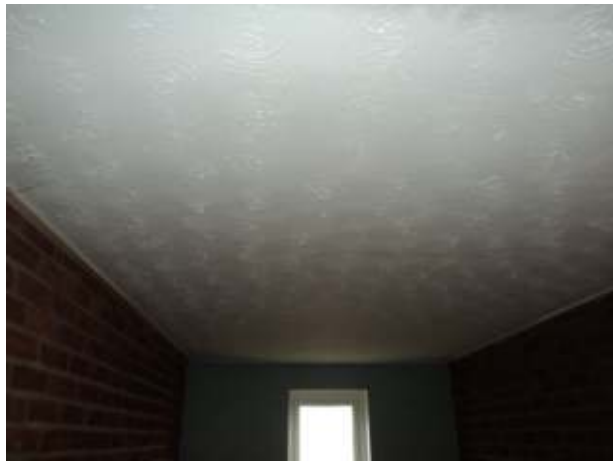
Our Sample Ref	Laboratory Sample Ref	Floor	Location	Description	Qty	Analysis Result	Total M.A.S	Notifiable Material Y/N
Refer 5350/13	Refer 107387	2 nd Floor	Landing	Ceiling Decorative Coating	9m ²	Chrysotile	2	N

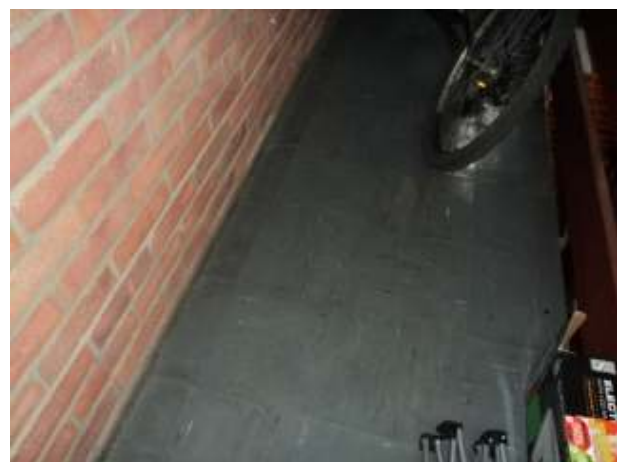
Our Sample Ref	Laboratory Sample Ref	Floor	Location	Description	Qty	Analysis Result	Total M.A.S	Notifiable Material Y/N
Refer 5350/14	Refer 107388	2 nd Floor	Landing	Floor Tile & Adhesive	6m ²	No asbestos detected in sample	N/A	N/A

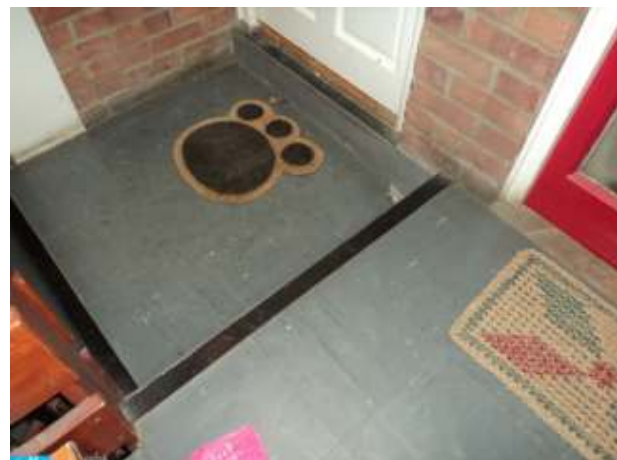
Our Sample Ref	Laboratory Sample Ref	Floor	Location	Description	Qty	Analysis Result	Total M.A.S	Notifiable Material Y/N
Refer 5350/15	Refer 107389	2 nd Floor	Landing	Step Nosing	2 no	No asbestos detected in sample	N/A	N/A

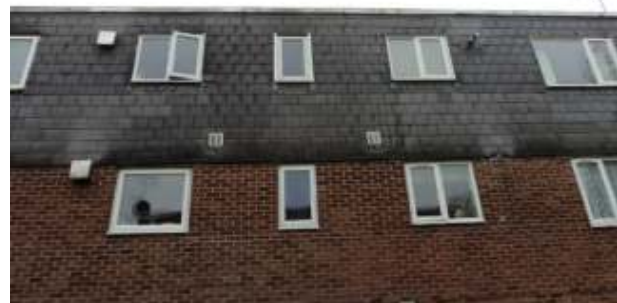
Our Sample Ref	Laboratory Sample Ref	Floor	Location	Description	Qty	Analysis Result	Total M.A.S	Notifiable Material Y/N
5350/16	107390	2 nd Floor	External Front & Rear Elevation	Asbestos Cement Shingles	80m ²	Chrysotile	3	N

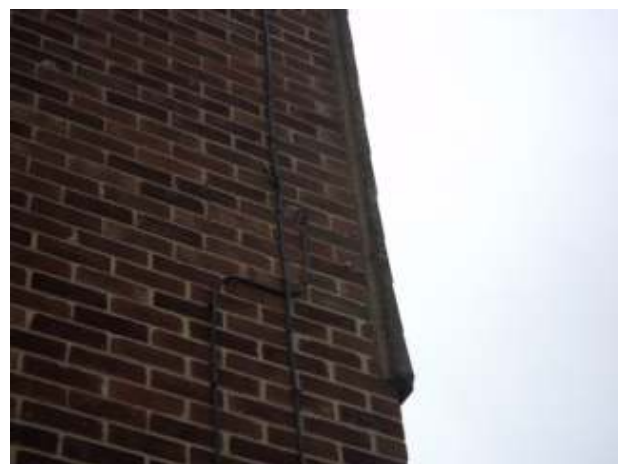
Our Sample Ref	Laboratory Sample Ref	Floor	Location	Description	Qty	Analysis Result	Total M.A.S	Notifiable Material Y/N
Refer 5350/16	Refer 107390	2 nd Floor	External Front & Rear Elevation	Asbestos Cement Under-Cloak	16m	Chrysotile	3	N

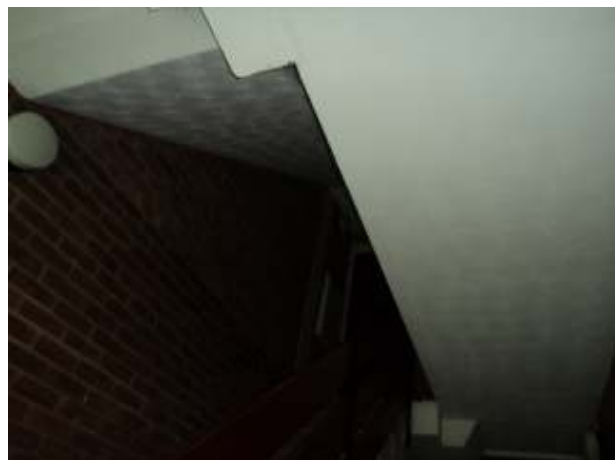
Our Sample Ref	Laboratory Sample Ref	Floor	Location	Description	Qty	Analysis Result	Total M.A.S	Notifiable Material Y/N
5350/17	107391	Ground Floor	Entrance Lobby	Ceiling Decorative Coating	11m ²	Chrysotile	2	N

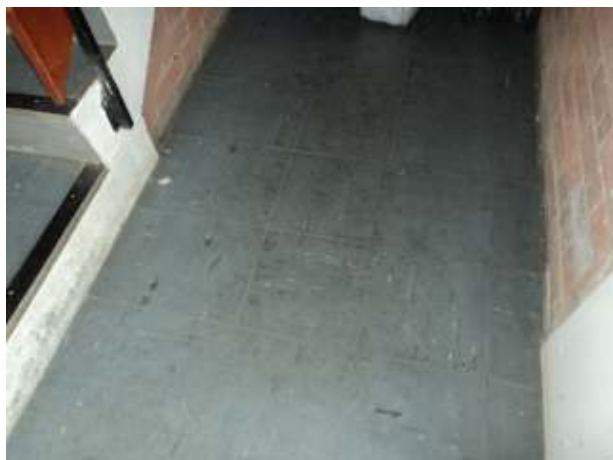
Our Sample Ref	Laboratory Sample Ref	Floor	Location	Description	Qty	Analysis Result	Total M.A.S	Notifiable Material Y/N
5350/18	107392	Ground Floor	Entrance Lobby	Floor & Stairs Tile & Adhesive	10m ²	No asbestos detected in sample	N/A	N/A
