COMBINED FIRE AND HEALTH & SAFETY RISK ASSESSMENT.

Address of premises:	Charminster Close Swindon SN3 3PZ
Responsible Person:	Charminster Close Residents Company Ltd
Duty Holder:	Block Management Limited
Person(s) consulted:	No occupier or other relevant person available to consult.
Assessor:	Rob Cockburn
Report validated by:	John Godfrey, GFireE.
Date of fire risk assessment:	24 th September 2024/ Reviewed September 2025
Date of previous fire risk assessment:	September 2022
Suggested date for review:	September 2026

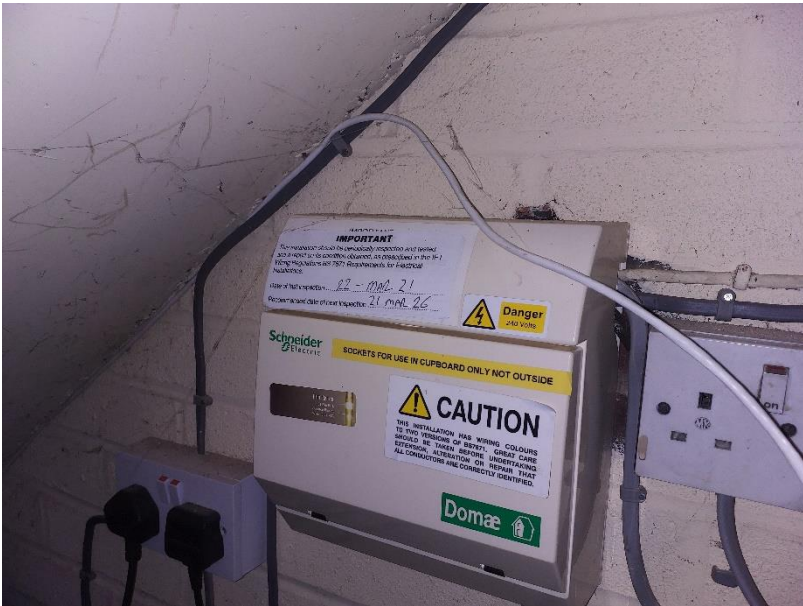
Item	Recommendation	Priority	Timescale
01	<p>According to the sticker attached to the consumer unit, the fixed electrical installation was last inspected and tested in March 2021 for all blocks.</p> <p>All fixed electrical installations supplying the communal areas of a residential property should be inspected and tested by a competent person every five years in accordance with Electricity at Work Regulations / IEE Wiring Regulations Eighteenth Edition 2019 / British Standard 7671: 2018 and a written Electrical Condition Report (EICR) obtained.</p> <p>It is recommended that the RP create a management action to ensure the electrical installation is retested on a five yearly rolling basis.</p>

3	C

No action required

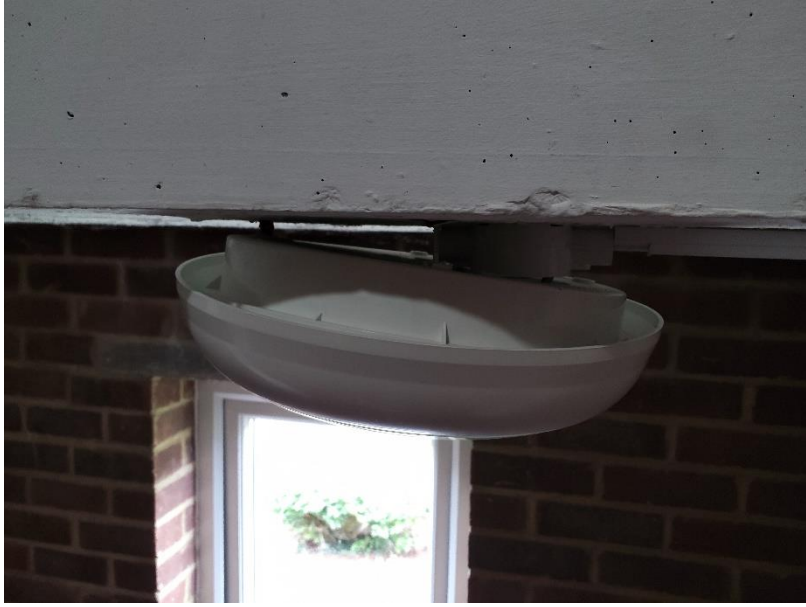
02	<p>It was noted during this fire risk assessment that multiple light fittings across all blocks were not fixed to the ceiling correctly. This could put strain on the wires which could lead to a potential electrical fire in the means of escape. It is therefore recommended that the RP instructs a suitably qualified and competent contractor to ensure all light fittings are fixed to the ceiling in order to protect the means of escape and light fittings from damage.</p>

2	B	<p>Action Required</p> <p>Electrician has reviewed the lights and carried out emergency light test</p>
03	<p>Housekeeping was found to be satisfactory at the time of this assessment for block 7-12, with all common areas and escape routes found to be free of combustibles and residents' storage. Care must be taken to avoid obstructing or blocking fire exit routes and this area must be monitored at all times.</p>	3	C	<p>Ongoing action required DH inspect communal areas</p>

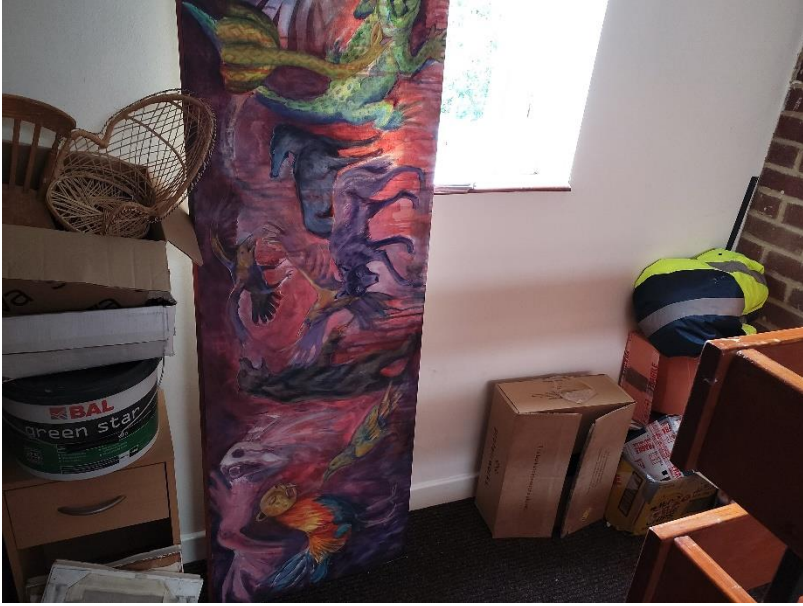
<p>04</p>	<p>Housekeeping was found to be of a poor standard at the time of this assessment within block 1-6, 13-18, 19-24, 25-30 with the communal areas and escape routes congested with residents' possessions and storage. It is recommended that the client arrange for the communal areas to be cleared as a priority and all residents reminded of the importance of maintaining sterile communal areas and escape routes.</p>

<p>2</p>	<p>B</p>	<p>Ongoing action required</p> <p>Residents are reminded to keep sterile area at all times, signage is maintained on communal notice board.</p> <p>DH inspects communal areas and tickets items for removal</p>
<p>05</p>	<p>All contractors employed by the client must supply risk assessments and method statements prior to working. It is recommended that the client give all contractors induction training prior to commencing work, which should include emergency procedures. Additionally, the client should arrange to conduct a post work inspection of the work area to ensure all works have been completed satisfactorily and safely, with no residual hazards present that could compromise the fire safety of the premises.</p>	<p>3</p>	<p>C</p>	<p>Ongoing action required</p> <p>DH actions as required</p>

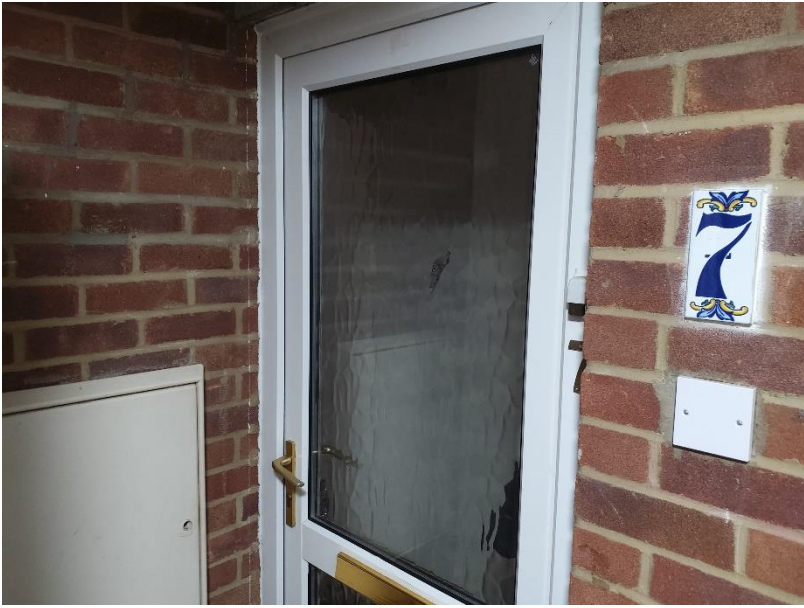
<p>06</p>	<p>It was noted during this fire risk assessment that units 7 and 14 have had the original doors replaced with UPVC which cannot guarantee a minimum of 30 minutes fire resistance. This could allow smoke and fire to spread into the means of escape which could compromise the stay put policy and impede persons escape from other units. It is therefore recommended that the RP instructs a suitably qualified and competent contractor to replace all UPVC doors with a FD30s fire doors complete with three grade 13 hinges, combined cold smoke and intumescent seals and an overhead closer in order to protect the means of escape as per Fire Safety (England) Regulations 2022 Fire Door Guidance Section 6.7A.</p> <p>Furthermore, it is essential that each flat entrance door is a suitable fire door, providing a minimum of thirty minutes fire resistance, hung on three grade 13 hinges and having a functioning self-closing device fitted that positively closes the door on the latch, together with smoke and intumescent seals. It is recommended therefore that the RP instruct a suitably qualified and competent contractor to conduct a fire door inspection to all flat entrance doors and communal area doors providing advice on suitability. Any shortcomings identified by this inspection should be addressed as a priority by upgrading or replacing the door. Flat entrance doors, communal area doors, the seals and the self-closing devices should then be subjected to an annual inspection and maintenance schedule.</p>

<p>1</p>	<p>B</p>	<p>Action required</p> <p>Apartment doors belong to individual apartment owner. DH provides information on fire doors via website and email.</p> <p>Last inspection July 2025</p>

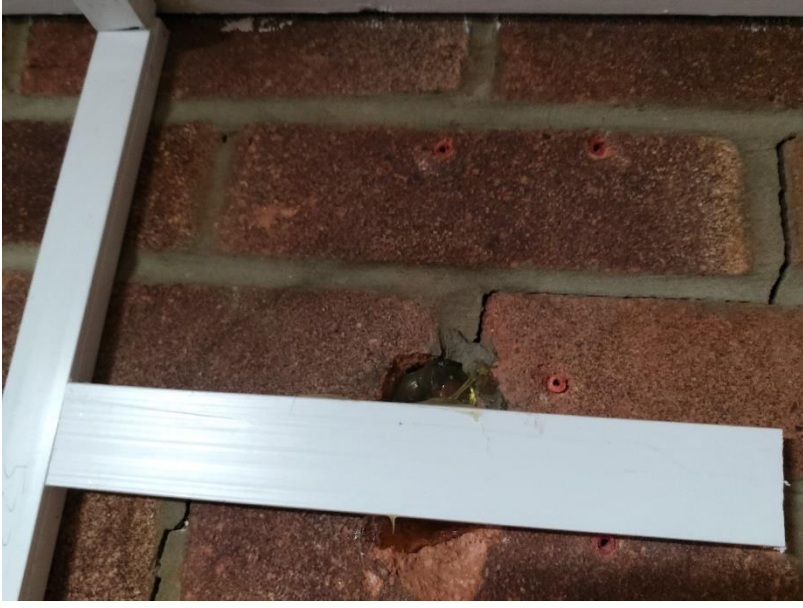
<p>09</p>	<p>It was noted during this fire risk assessments that there were breaches to the fire stopping or compartmentation within the communal area in the following areas:</p> <ul style="list-style-type: none"> • Small breach outside unit 29 • Small breaches along the ceiling of the first and ground floor of multiple blocks • Small breach on the wall outside unit 23 • Small breach on the ceiling outside unit 16 • Small breach on the wall outside unit 15 • Small breach outside unit 11 • Fire stopping poor outside unit 6 • Small breach on the ceiling at the ground floor staircase <p>This could allow smoke and fire to spread into the means of escape. It is therefore recommended that the RP instructs a suitably qualified and competent contractor to undertake a passive fire survey, any deficiencies found in the fire stopping or compartmentation should be actioned as a priority as per Fire Safety in Purpose Built Block of Flats Section 54.3 and 54.4.</p>

<p>1</p>	<p>B</p>	<p>Action required</p> <p>Action complete</p>
