Asbestos Management Survey Report

(Carried out for Charminster Close
Residents Company Ltd)

Charminster Close, Blocks A-E, Nythe, Swindon,
SN3 3QB

Checked by:	J O'Sullivan
Verified/Signature:	
Date of Survey:	5 April 2011
Date of Report:	14 th April 2011
<u>Our Reference:</u>	<u>SAS5350</u>
Authorising Surveyor:	Kerry Salter
Verified/Signature:

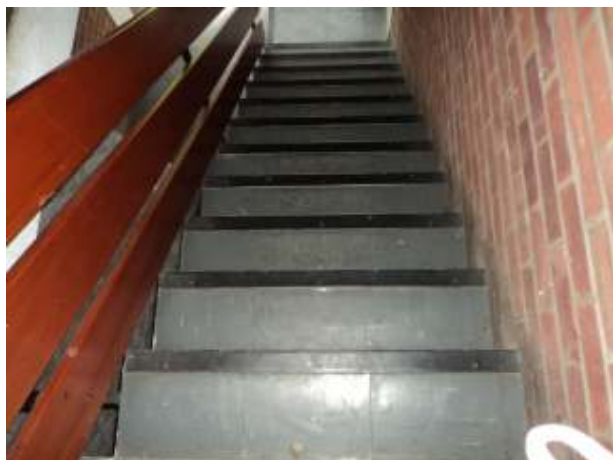
Detail sheet - Unique Job Number SAS5350

Our Sample Ref	Laboratory Sample Ref	Floor	Location	Description	Qty	Analysis Result	Total M.A.S	Notifiable Material Y/N
5350/19	107393	Ground Floor	Entrance Lobby	Stair Nosings	13 no	No asbestos detected in sample	N/A	N/A

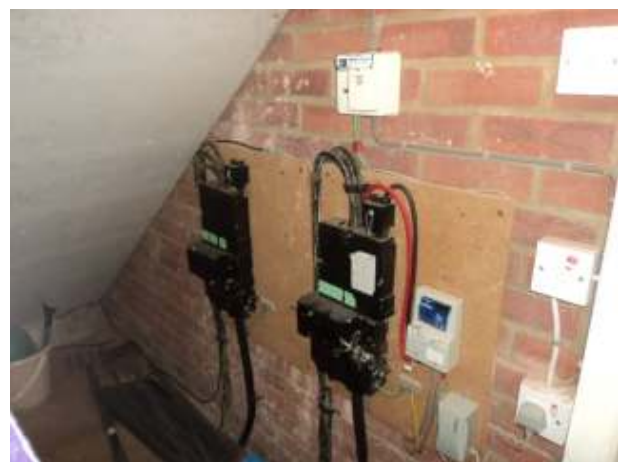
Detail sheet - Unique Job Number SAS5350

Our Sample Ref	Laboratory Sample Ref	Floor	Location	Description	Qty	Analysis Result	Total M.A.S	Notifiable Material Y/N
Presumed	Presumed	Ground Floor	Cleaners Store Wall	Switch Gear Textile	3 units	Chrysotile	4	N

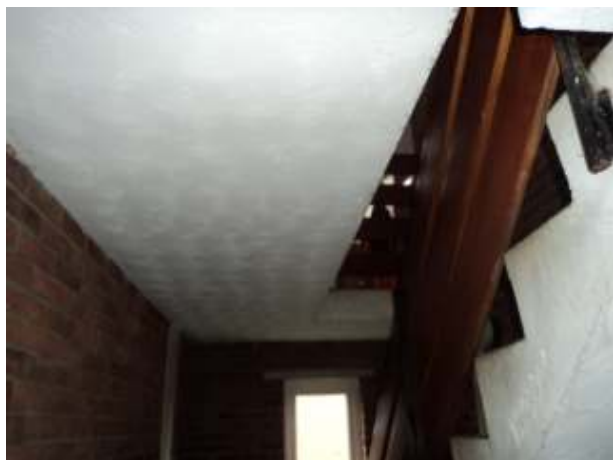
Detail sheet - Unique Job Number SAS5350

Our Sample Ref	Laboratory Sample Ref	Floor	Location	Description	Qty	Analysis Result	Total M.A.S	Notifiable Material Y/N
Refer 5350/17	Refer 107391	1 st Floor	Landing	Ceiling Decorative Coating	8m ²	Chrysotile	2	N

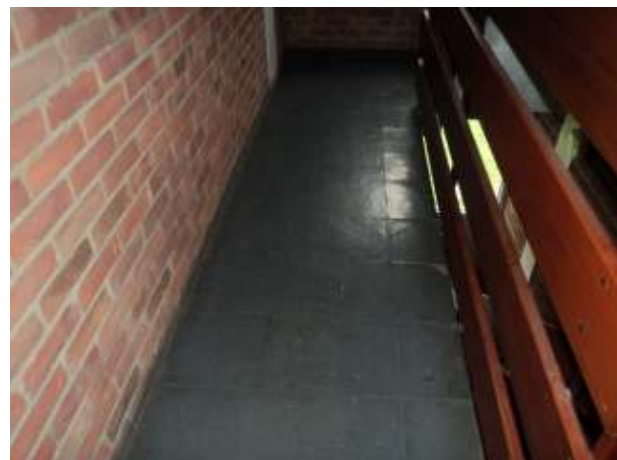
Detail sheet - Unique Job Number SAS5350

Our Sample Ref	Laboratory Sample Ref	Floor	Location	Description	Qty	Analysis Result	Total M.A.S	Notifiable Material Y/N
Refer 5350/18	Refer 107392	1 st Floor	Landing	Floor & Stairs Tile & Adhesive	12m ²	No asbestos detected in sample	N/A	N/A

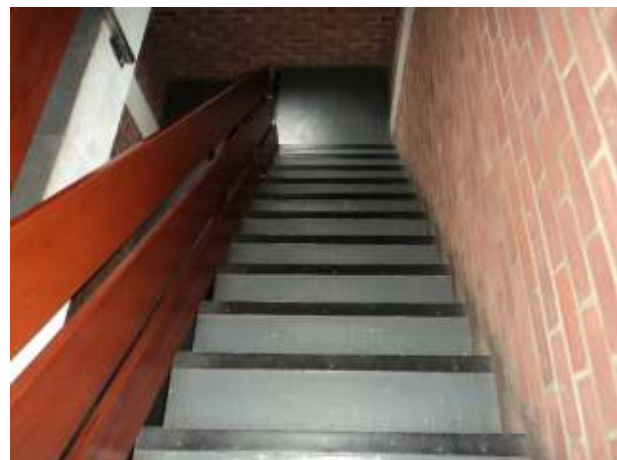
Detail sheet - Unique Job Number SAS5350

Our Sample Ref	Laboratory Sample Ref	Floor	Location	Description	Qty	Analysis Result	Total M.A.S	Notifiable Material Y/N
Refer 5350/19	Refer 107393	1 st Floor	Landing	Stair Nosings	13 no	No asbestos detected in sample	N/A	N/A

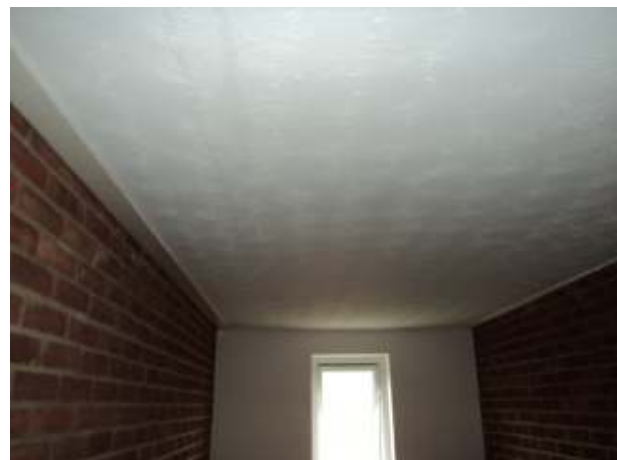
Detail sheet - Unique Job Number SAS5350

Our Sample Ref	Laboratory Sample Ref	Floor	Location	Description	Qty	Analysis Result	Total M.A.S	Notifiable Material Y/N
Refer 5350/17	Refer 107391	2 nd Floor	Landing	Ceiling Decorative Coating	9m ²	Chrysotile	2	N

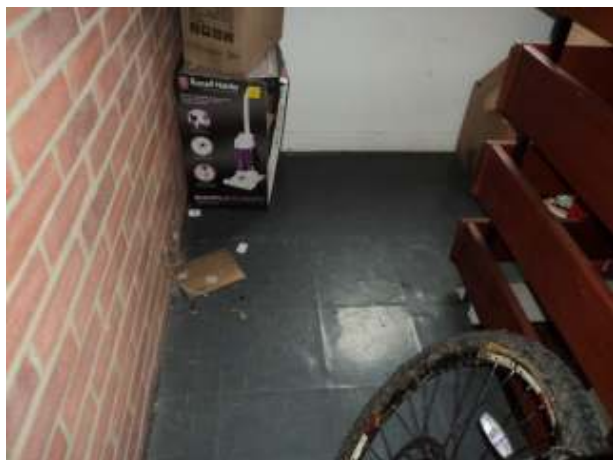
Detail sheet - Unique Job Number SAS5350

Our Sample Ref	Laboratory Sample Ref	Floor	Location	Description	Qty	Analysis Result	Total M.A.S	Notifiable Material Y/N
Refer 5350/18	Refer 107392	2 nd Floor	Landing	Floor Tile & Adhesive	6m ²	No asbestos detected in sample	N/A	N/A

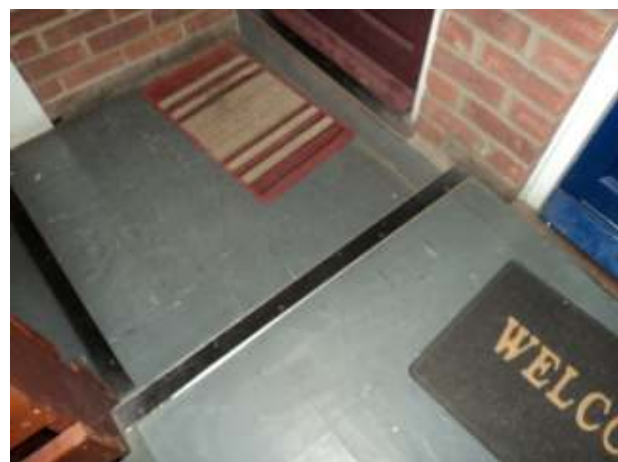
Detail sheet - Unique Job Number SAS5350

Our Sample Ref	Laboratory Sample Ref	Floor	Location	Description	Qty	Analysis Result	Total M.A.S	Notifiable Material Y/N
Refer 5350/19	Refer 107393	2 nd Floor	Landing	Step Nosing	2 no	No asbestos detected in sample	N/A	N/A

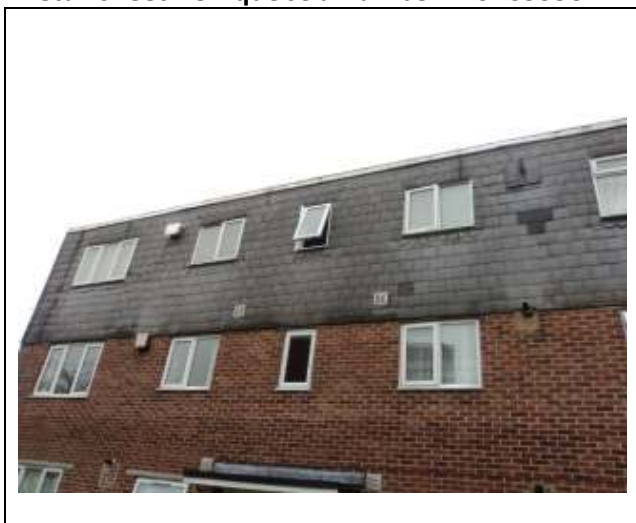
Detail sheet - Unique Job Number SAS5350

Our Sample Ref	Laboratory Sample Ref	Floor	Location	Description	Qty	Analysis Result	Total M.A.S	Notifiable Material Y/N
5350/20	107394	2 nd Floor	External Front & Rear Elevation	Asbestos Cement Shingles	80m ²	Chrysotile	3	N

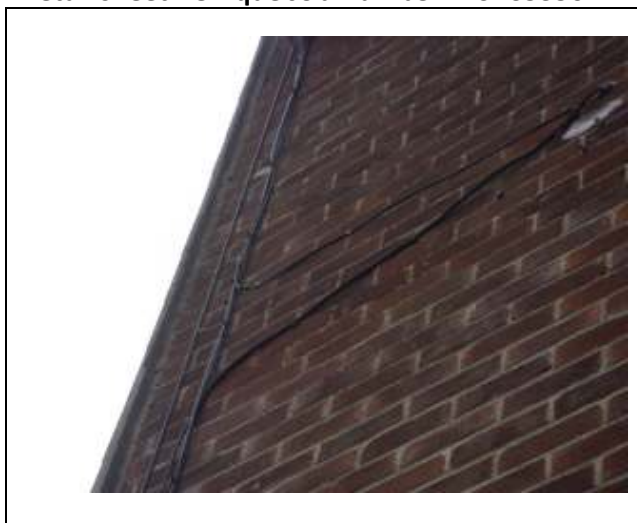
Detail sheet - Unique Job Number SAS5350

Our Sample Ref	Laboratory Sample Ref	Floor	Location	Description	Qty	Analysis Result	Total M.A.S	Notifiable Material Y/N
Refer 5350/20	Refer 107394	2 nd Floor	External Front & Rear Elevation	Asbestos Cement Under-Cloak	16m	Chrysotile	3	N

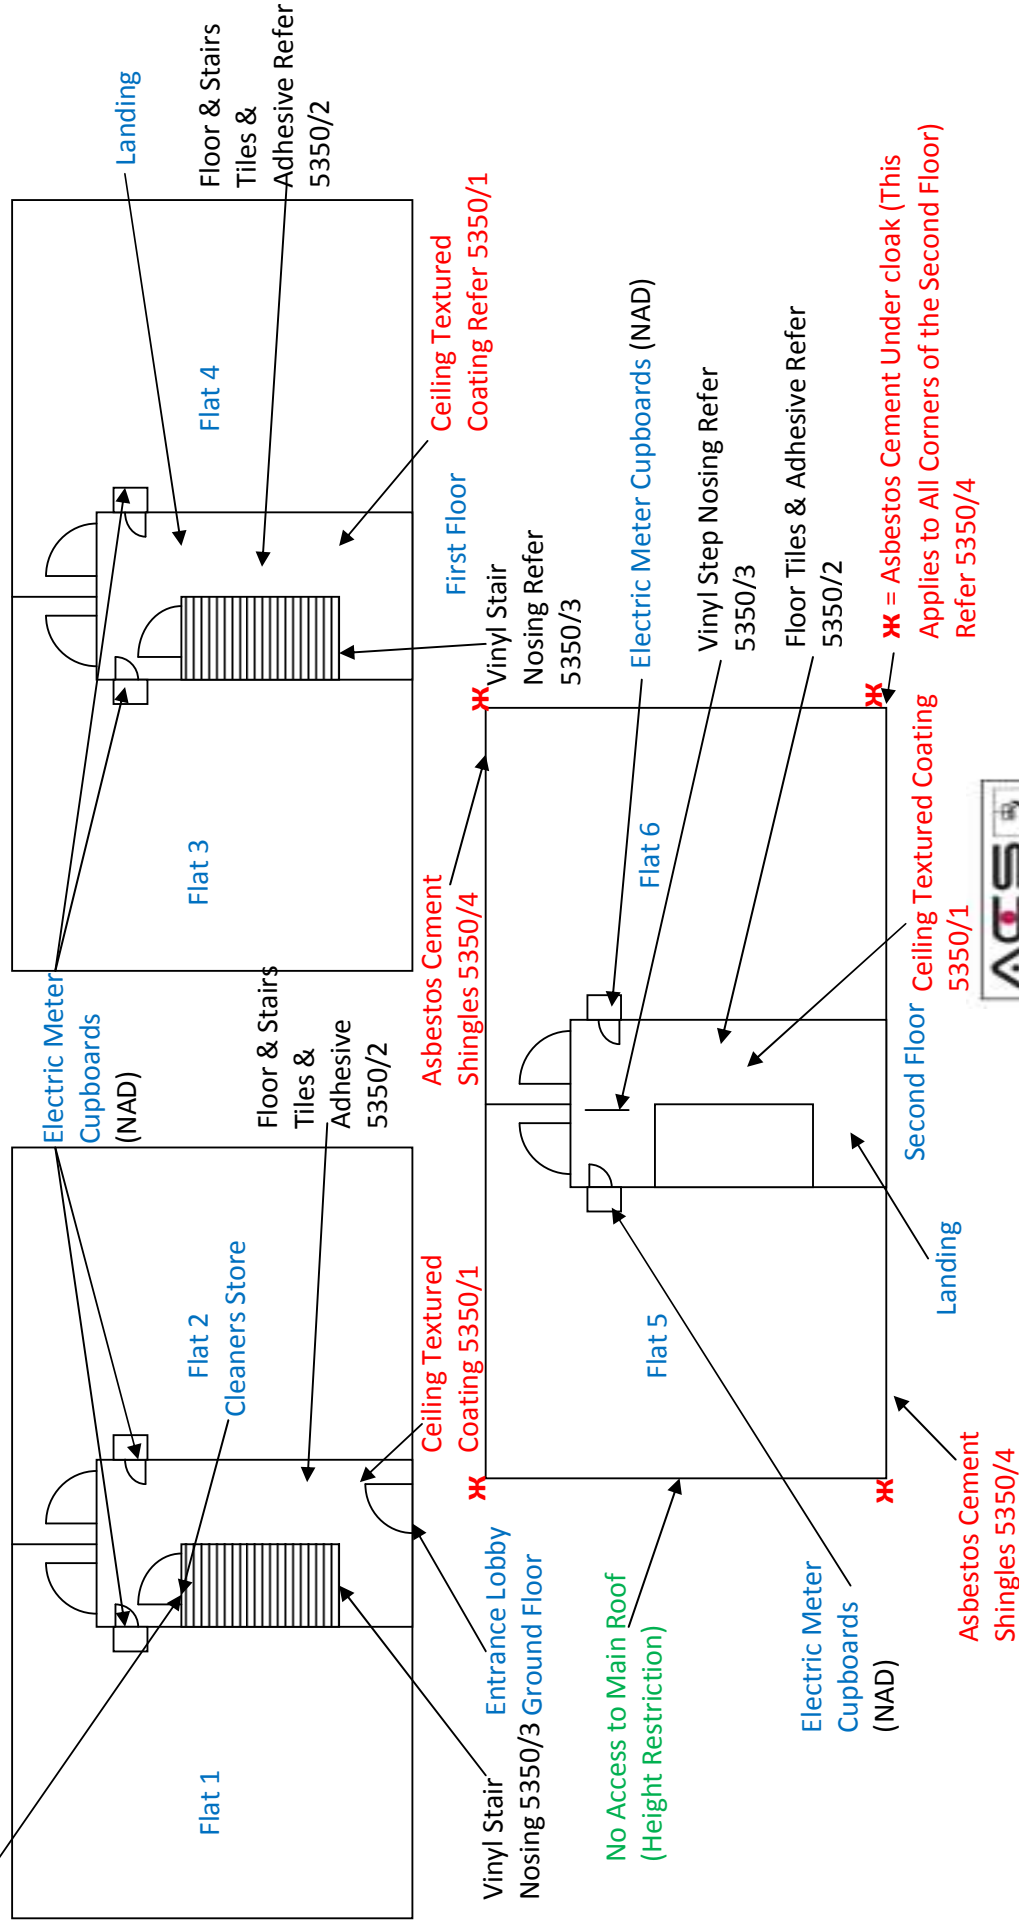
Charminster Close, Nythe, Swindon, SN3 3QB – Floor Plan Block A Page 1 of 5

Presumed Asbestos
Textile to Switch
Gear
